Speed Limit Submission

for
Rotoiti East
to
RLC and Waka Kotahi NZ Transport Agency
2021 Review of Rotorua District Speed Limits

Speed Limit Submission from LRCA

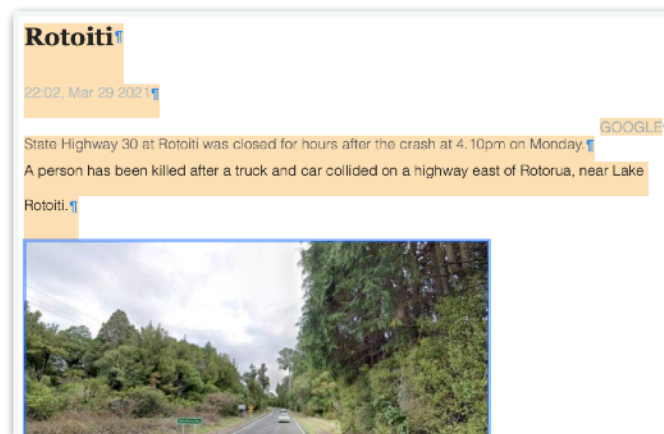
One person killed after a truck and car collided at Hongi's Track - 29 March 2021

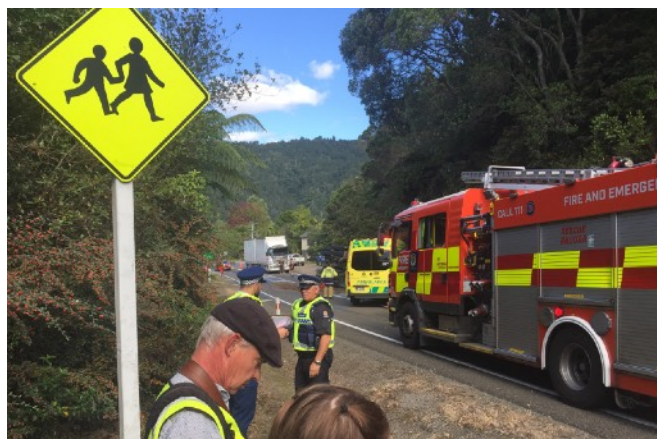
Truck & trailer rolls at Ruato Bay blocking highway for 16hrs - 6 April 2021

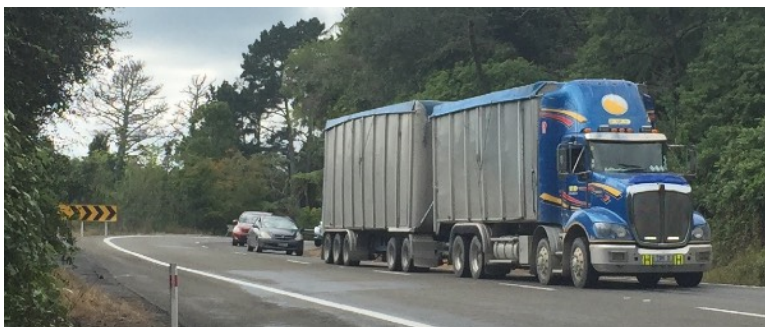
1. Many large truck and trailer units use the route - they may not be in danger but anyone in their path certainly is and they have minimal ability to avoid danger at 80 to 100kph

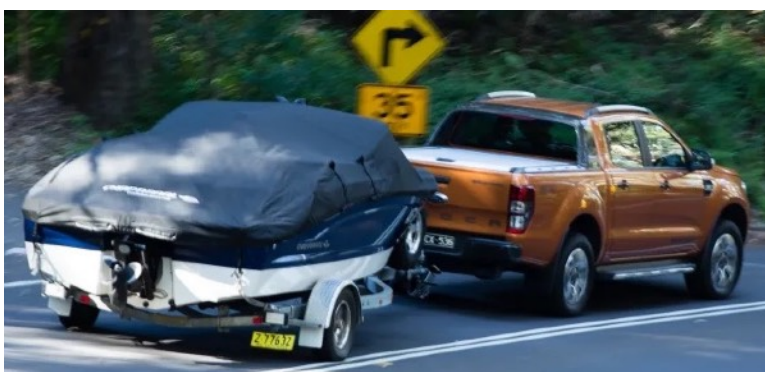
2. Many vehicles using, accessing and leaving the road are towing heavy trailers making them a large sitting targets with limited manoeuvrability

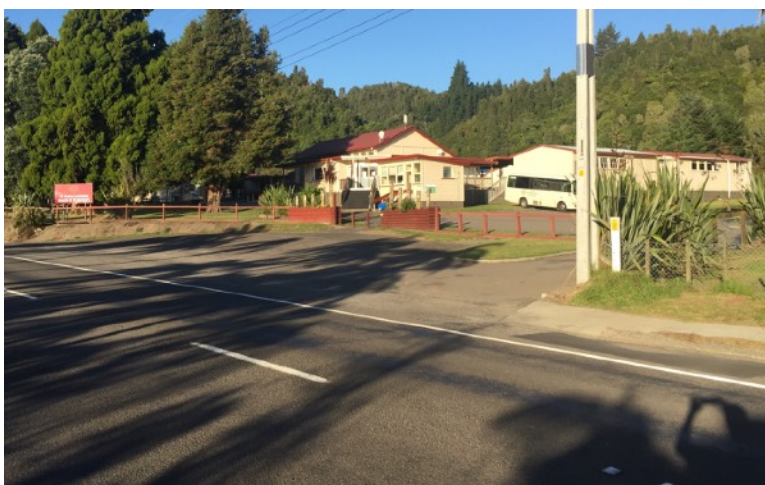
3. Many in the East Rotoiti community are either elderly or young, (including school children), and in both cases are vulnerable walking beside and crossing the road when vehicles are travelling at 80kph or more

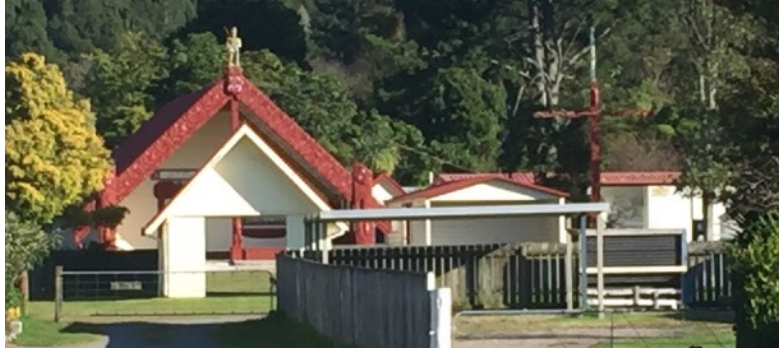
4. Large numbers of people attending events at Maraes such as Tangis, festivities or huis maybe preoccupied with other matters - eg grief - and more at risk

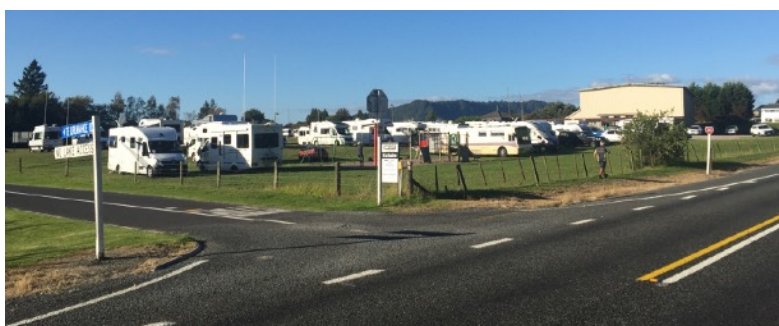
5. Likewise members or visitors to the Rugby or Golf Clubs during the day or in the evening
6. Tourists unfamiliar with NZ country roads
7. Speeding motorists taking risks passing other vehicles on the few short straight stretches with concealed driveways
8. Drivers, eg holiday visitors, unfamiliar with the safest ways to access the highway from driveways with difficult access and very restricted vision of the clear road available to do so

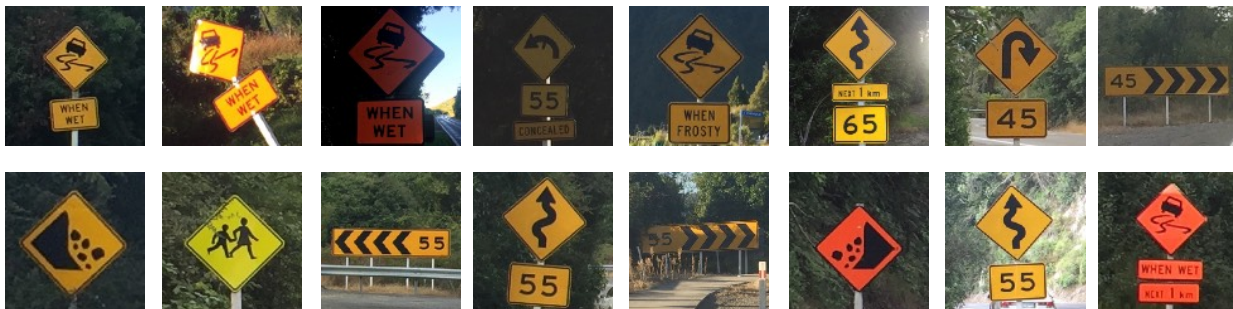
Where there is limited population multiple hazards exist - such as sharp, corners, rockfalls, slippery road in icy and wet conditions, unforgiving borders either through large drop offs directly into the lake or into substantial tree trunks. The highway is peppered with signs warning that corners / windy road should be driven at 45kph, 55kph and 65kph, that it is slippery in icy or wet conditions and that drivers should watch out for rockfalls and pedestrians.

The road warning signs in these areas make it clear that driving at 60kph or less is advised and driving at 100kph is dangerous!

We submit that the speed limit for the section of road between Moose Lodge and Hongi's Track be reduced to 60kph.
